## Agenda Linn-Benton Loop TAC Meeting Hybrid Meeting

The evaluation focused primarily on two major hubs in Albany: Linn-Benton Community College (LBCC) and the Albany Amtrak Station. Both locations serve as major regional connection points with high passenger activity, multiple transit providers, and frequent navigation challenges reported by riders and agency staff. To identify systemwide needs, the study also examined conditions at the Heritage Mall stop on Clay Street and the North Albany Park & Ride, where similar issues with signage, circulation, and multimodal connections were documented. Findings across all four locations informed recommendations for both near-term, low-cost improvements and longer-term infrastructure enhancements aimed at improving clarity, accessibility, and interagency coordination.

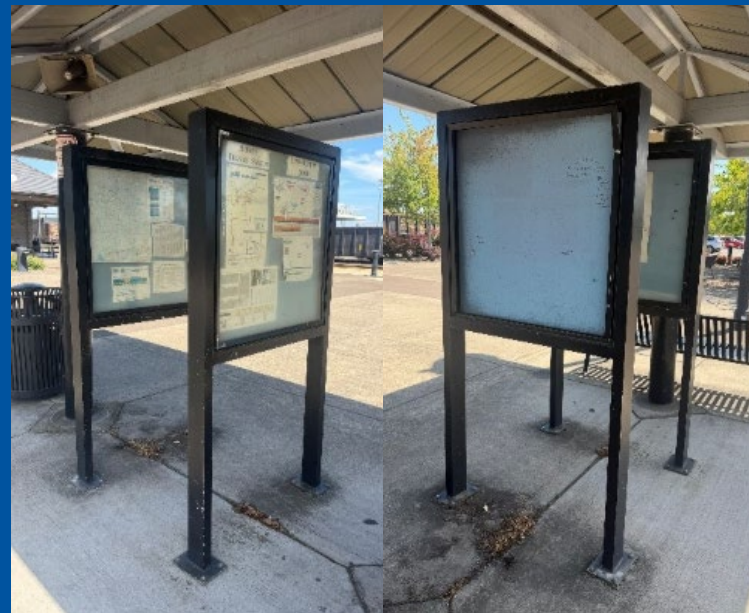
Information Billboards

Damaged Side

1. Add agency signage to shelters.
2. Mark primary boarding zones.
3. Update/remove outdated signage.
4. Repair/replace bulletin boards.

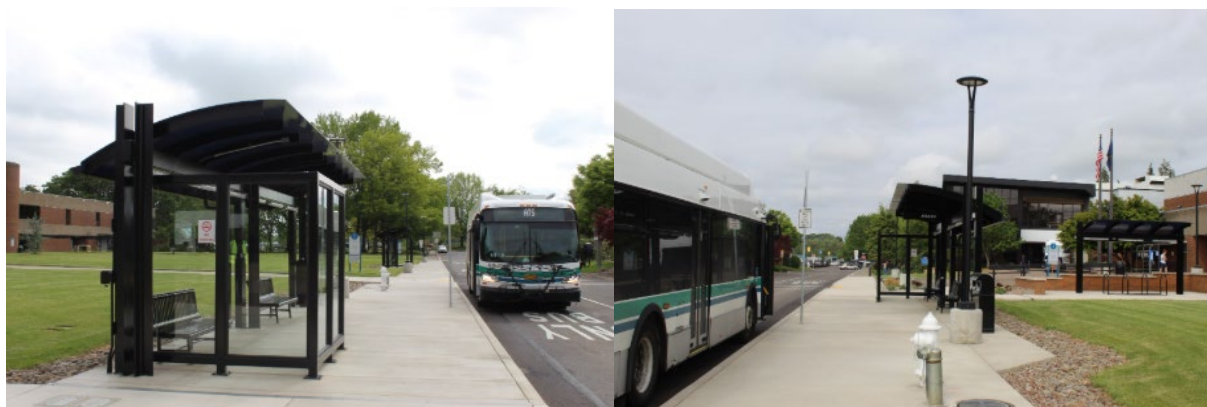
**Figure 2-1 & 2-2 ATS Boarding at Second Bus Shelter**

Figures 2-1 and 2-2 show an Albany Transit Service bus boarding at the second bus shelter. The two-shelter layout has the potential to work effectively if multiple agencies consistently coordinate their use and clearly designate shared boarding points. However, because ATS, the Linn Shuttle, and the Loop each use different boarding locations under current operating practices, the layout is less intuitive for riders. In this context, the addition of a third shelter would more closely align with how services function today and provide a clearer, more predictable structure for users. This observation aligns with comments from both the Linn Shuttle operations lead and the ATS Transit Manager, who noted that earlier discussions envisioned three shelters.

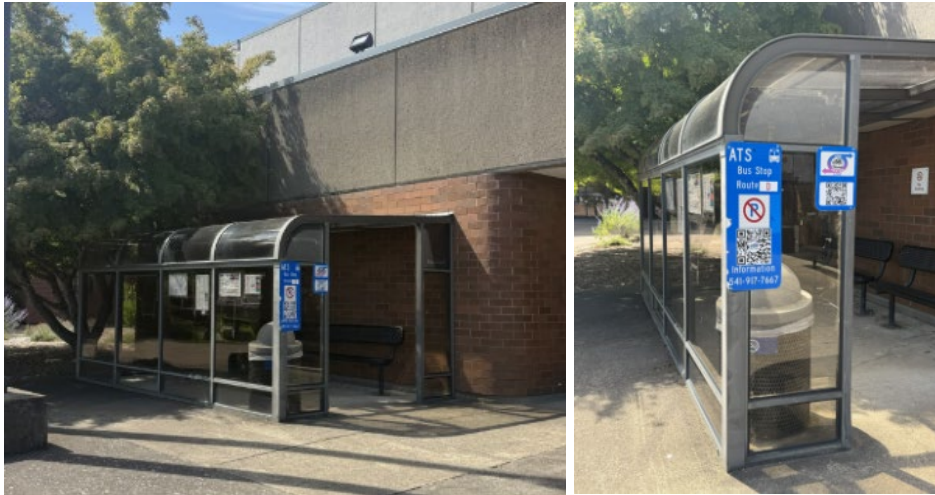
**Figure 1-1 & 4-2 Bus Shelter Attached to LBCC Building**

Overall, signage at the LBCC transit hub is inconsistent, and in some cases, misleading. Figure 3 shows one of the two hanging signs labeled ‘ATS/Linn’ in the bus shelters. This signage suggests that both services use both shelters, contradicting the actual operating patterns. Riders entering/exiting LBCC buildings also lack directional cues guiding them to the appropriate shelter, making first-time navigation difficult. Figures 4-1 and 4-2 show the shelter directly next to the building, with route signage for ATS and Loop, along with some information printed and placed on the interior windows. This shelter would be a great location to add more wayfinding signage, route information, and other important details students and other riders may need.

- **Permanent Shelter-Specific Sign Replacement:** Replace dual-agency hanging signs in shelters with clear shelter-specific labels using consistent logos, symbols, and/or colors. If boarding practices remain the same, Linn Shuttle should be signed at the first shelter and ATS signed at the second shelter.

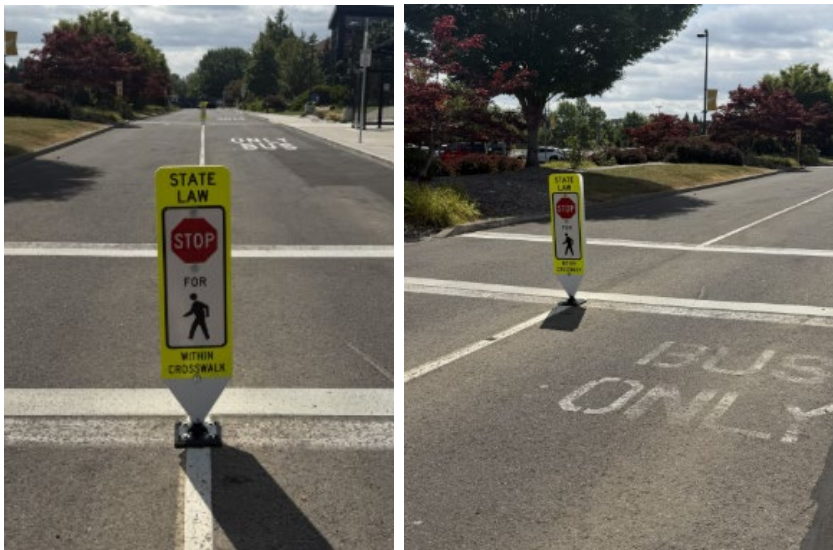
**Figure 5-1 & 5-2 Pavement-Embedded Signage at LBCC**

Figures 5-1 and 5-2 show two pavement-embedded pedestrian crossing signs located on the center median line that add further complications to the LBCC transit hub. The Linn-Shuttle operations lead shared that buses have repeatedly struck the sign because of its placement, and ATS confirmed they have paid to repair or replace them several times. The signs disrupt bus circulation and create maneuverability challenges during peak travel times.

Operational constraints add to these difficulties and produce a fragmented visual environment. The circulation challenges caused by the pavement-embedded signs, along with inconsistent signage practices across ATS, Linn-Benton Loop, and Linn Shuttle, produce a fragmented visual environment. As stakeholders emphasized, consistent placement and timing of signs are essential for predictable navigation, yet these standards are not currently met.

1. Replace dual-agency shelter signage.
2. Permanent Linn-Benton Loop boarding area.
3. Third bus shelter.
4. Unified regional branding across agencies.
5. Coordinate campus signage with transit wayfinding.
6. Redesign or removal of pavement-embedded signage.

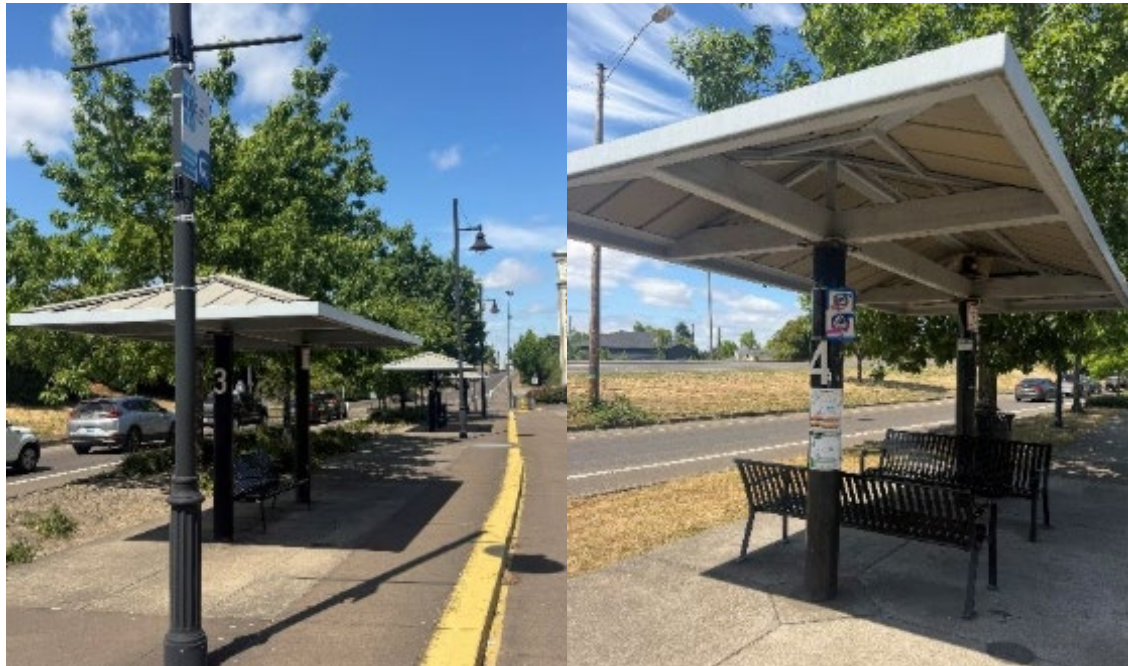
**Figure 7-1, 7-2 & 7-3 Albany Amtrak Station Numbered Shelters**

Signage across the station is inconsistent between agencies, with some routes having little to no visible branding. This makes it harder for riders who rely on symbols or logos, including children, limited-English speakers, and low-literacy users, to identify services. As seen in figures 7-1, 7-2 and 7-3, shelters at the Albany Amtrak Station are each labeled with numbers but have inconsistent route signage. For example, shelter 3 has signage for Benton Area Transit on the light pole next to the shelter, shelter 4 has signage for the Linn-Benton Loop and some maps on the shelter itself, and shelter 6 has no signage at all.

- **Shelter Labels, Agency Logos, and Route Labels:** Add clear shelter-specific agency logos, route identifiers, and/or different colored poles so riders know which services board at each numbered shelter. These permanent decals or sign panels greatly reduce confusion.
- **Primary Board Zone Markings:** Identify the primary boarding locations with paint, bollards, or posts, improving intuitive navigation between shelters without needing structural changes.
- **Replace Outdated “Valley Retriever” Sign:** Update or remove outdated signage in the grass area to reflect current transit services. A new decal on the sign can be installed quickly and inexpensively if no replacement is made.
- **Repair or Replace the Billboard Cases:** Install a stable bulletin board case to ensure posted materials remain secure, visible and up to date. This is a permanent improvement with modest cost.

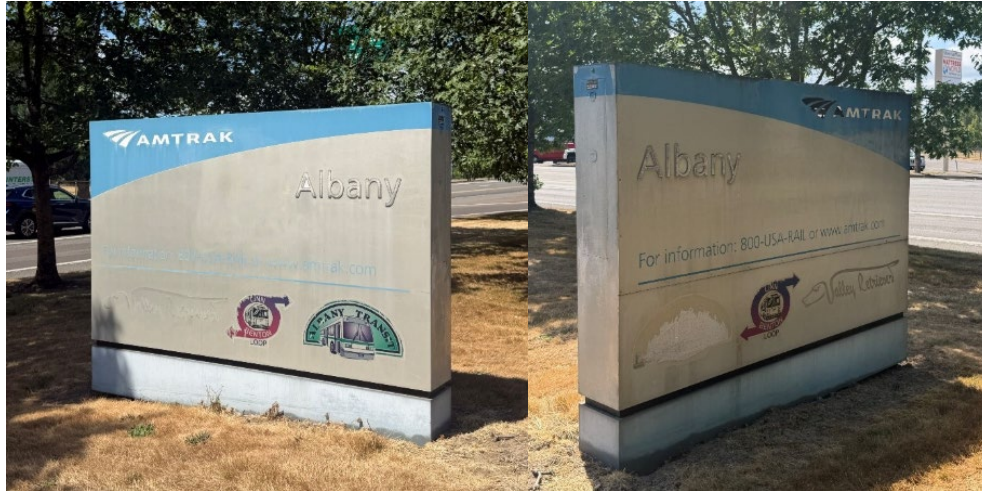
**Figure 8-1 & 8-2 Large Outdated Sign at Albany Amtrak Station**

1. A large grass-area sign still displays obsolete “Valley Retriever” branding. *Shown in figures 8-1 and 8-2.*
2. The station’s informational billboard is physically unstable, requiring staff support when posting materials. *Shown in figures 9-1, 9-2 and 9-3.*

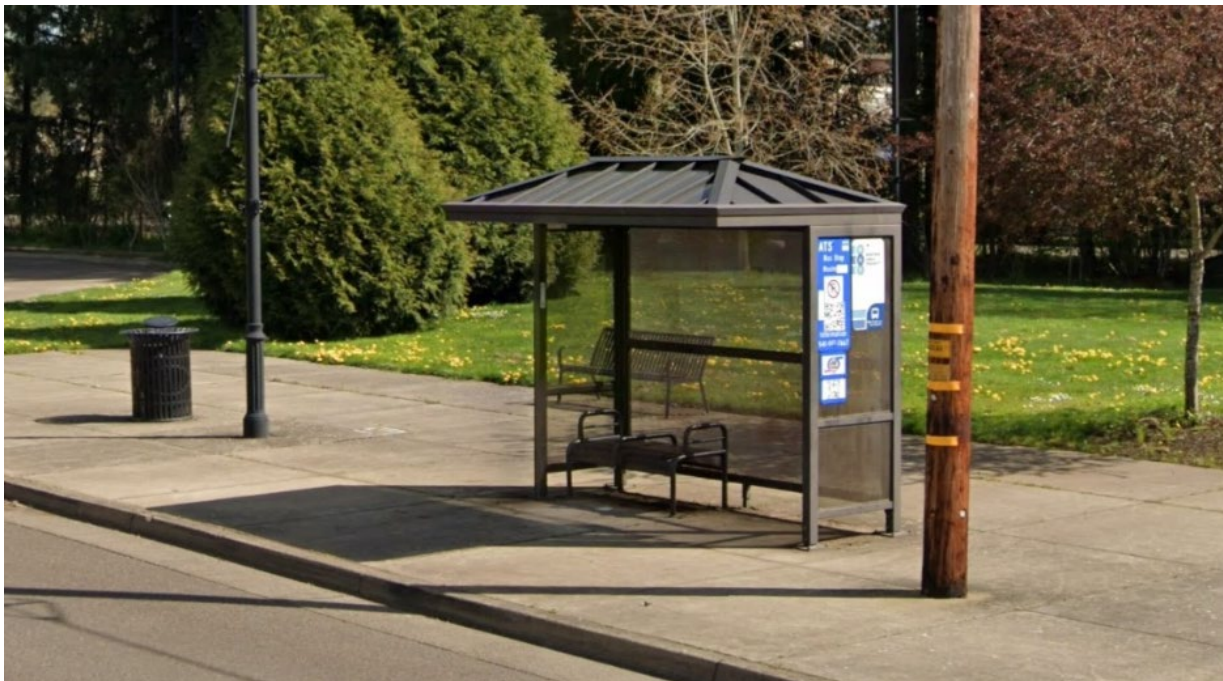
**Figure 13 Bus Shelter and Signage at North Albany Park & Ride**

Site observations and stakeholder interviews described the shelter as visually appealing and structurally sound. However, the stop's location on a side street limits its visibility to people who are not already familiar with the transit system. Riders traveling between Albany and Benton County may not realize that the Park & Ride provides regional connections, even if they pass by it regularly. One ATS stakeholder noted that although they had lived in North Albany for several years and drove past the site frequently, they did not know it existed until beginning to work with ATS. This highlights a broader issue of low community awareness rather than inadequate physical infrastructure.

Stakeholders also shared that the site previously included bike storage, but the equipment was removed due to security concerns. Without amenities that signal multimodal use, the stop blends into its surroundings and does not communicate its role as a regional hub to pedestrians and cyclists. This challenge mirrors broader systemwide issues where stops are functional but not widely recognized by potential riders. Figure 13 shows the current condition and amenities at the North Albany Park & Ride, with a focus on the bus shelter and route signage.

- Conduct outreach to increase locations visibility.
